Service Information

Category U	Repair Guidance	Ref. No. R024/06	Page 1 of 2
Coverage <input type="checkbox"/> Distributor only <input checked="" type="checkbox"/> Please inform your dealers		Date Issued March 31, 2006	
Please convey this information to your <input type="checkbox"/> Director <input checked="" type="checkbox"/> General Manager <input checked="" type="checkbox"/> Warranty Dept. <input checked="" type="checkbox"/> Parts Dept. <input checked="" type="checkbox"/> Training Dept. <input checked="" type="checkbox"/> Field Rep.		Date Revised	
Applicable Model Mazda6 (GG/GY) & Mazda5 (CR) with MZR-CD Engine	Applicable Countries or Specifications Europe

Subject: Unusual Noise from Drive Belt

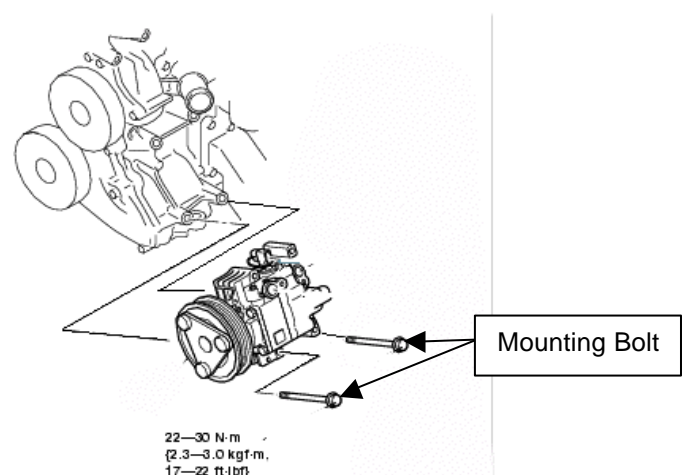
When the vehicle is at idle or running at a low speed (30 – 50 km/h) with the accelerator pedal released, an unusual noise may be heard from the drive belt.

There is misalignment between the crank pulley and A/C compressor, which causes the unusual noise.

1. Remove the right side tire.
2. Remove the right side splash shield and mudguard.
3. Loosen the drive belt and remove it.

4. Loosen the 4 mounting bolts from AC compressor.
5. Move the AC compressor, and remove the 2 mounting bolts as indicated in the figure.
6. Install 2 service mounting bolts in the AC compressor.
7. Tighten the four mounting bolts to the specified tightening torque.
Tightening Torque: 22-30Nm
