Category <b>U</b>	<b>Technical</b>	Ref. No. E002/05	Page 1 of 1
Coverage <input type="checkbox"/> Distributor only <input checked="" type="checkbox"/> Please inform your dealers		Date Issued February 7, 2005	
Please convey this information to your <input type="checkbox"/> Director <input checked="" type="checkbox"/> General Manager <input checked="" type="checkbox"/> Warranty Dept. <input checked="" type="checkbox"/> Parts Dept. <input checked="" type="checkbox"/> Training Dept. <input checked="" type="checkbox"/> Field Rep.		Date Revised	
Applicable Models  Mazda3 (BK) with Auto A/C		Applicable Countries or Specifications  Worldwide (except North America)

## Subject: Temperature Display Indicates Too High (Auto A/C)

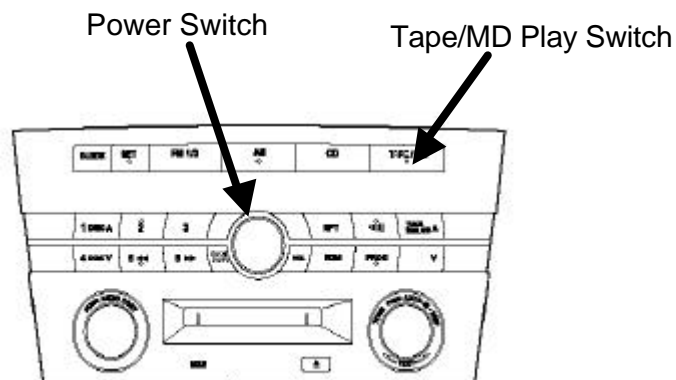
Some customers may complain that the auto A/C's temperature display indicates too high (60 – 90 degrees).

When both of the audio power switch and tape/MD play switch are held pressed for approximately two seconds, the temperature display automatically changes from Celsius to Fahrenheit by itself.

This is a normal function of the auto A/C and not a problem.

When you encounter a customer complaint on this concern, first confirm with the customer how s/he operates the audio switches.

If the customer uses the same operation as mentioned above, change the temperature display back to Celsius by performing the same operation (holding both of the audio power switch and tape/MD play switch pressed for approximately two seconds), and then explain the customer this is not a problem.
